HISTORIC AMERICAN BUILDINGS SURVEY
INVENTORY

2. NAME *Orrin Thompson Mansion*

DATE OR PERIOD *1832*
STYLE *Greek Revival*
ARCHITECT
BUILDER *Orrin Thompson*

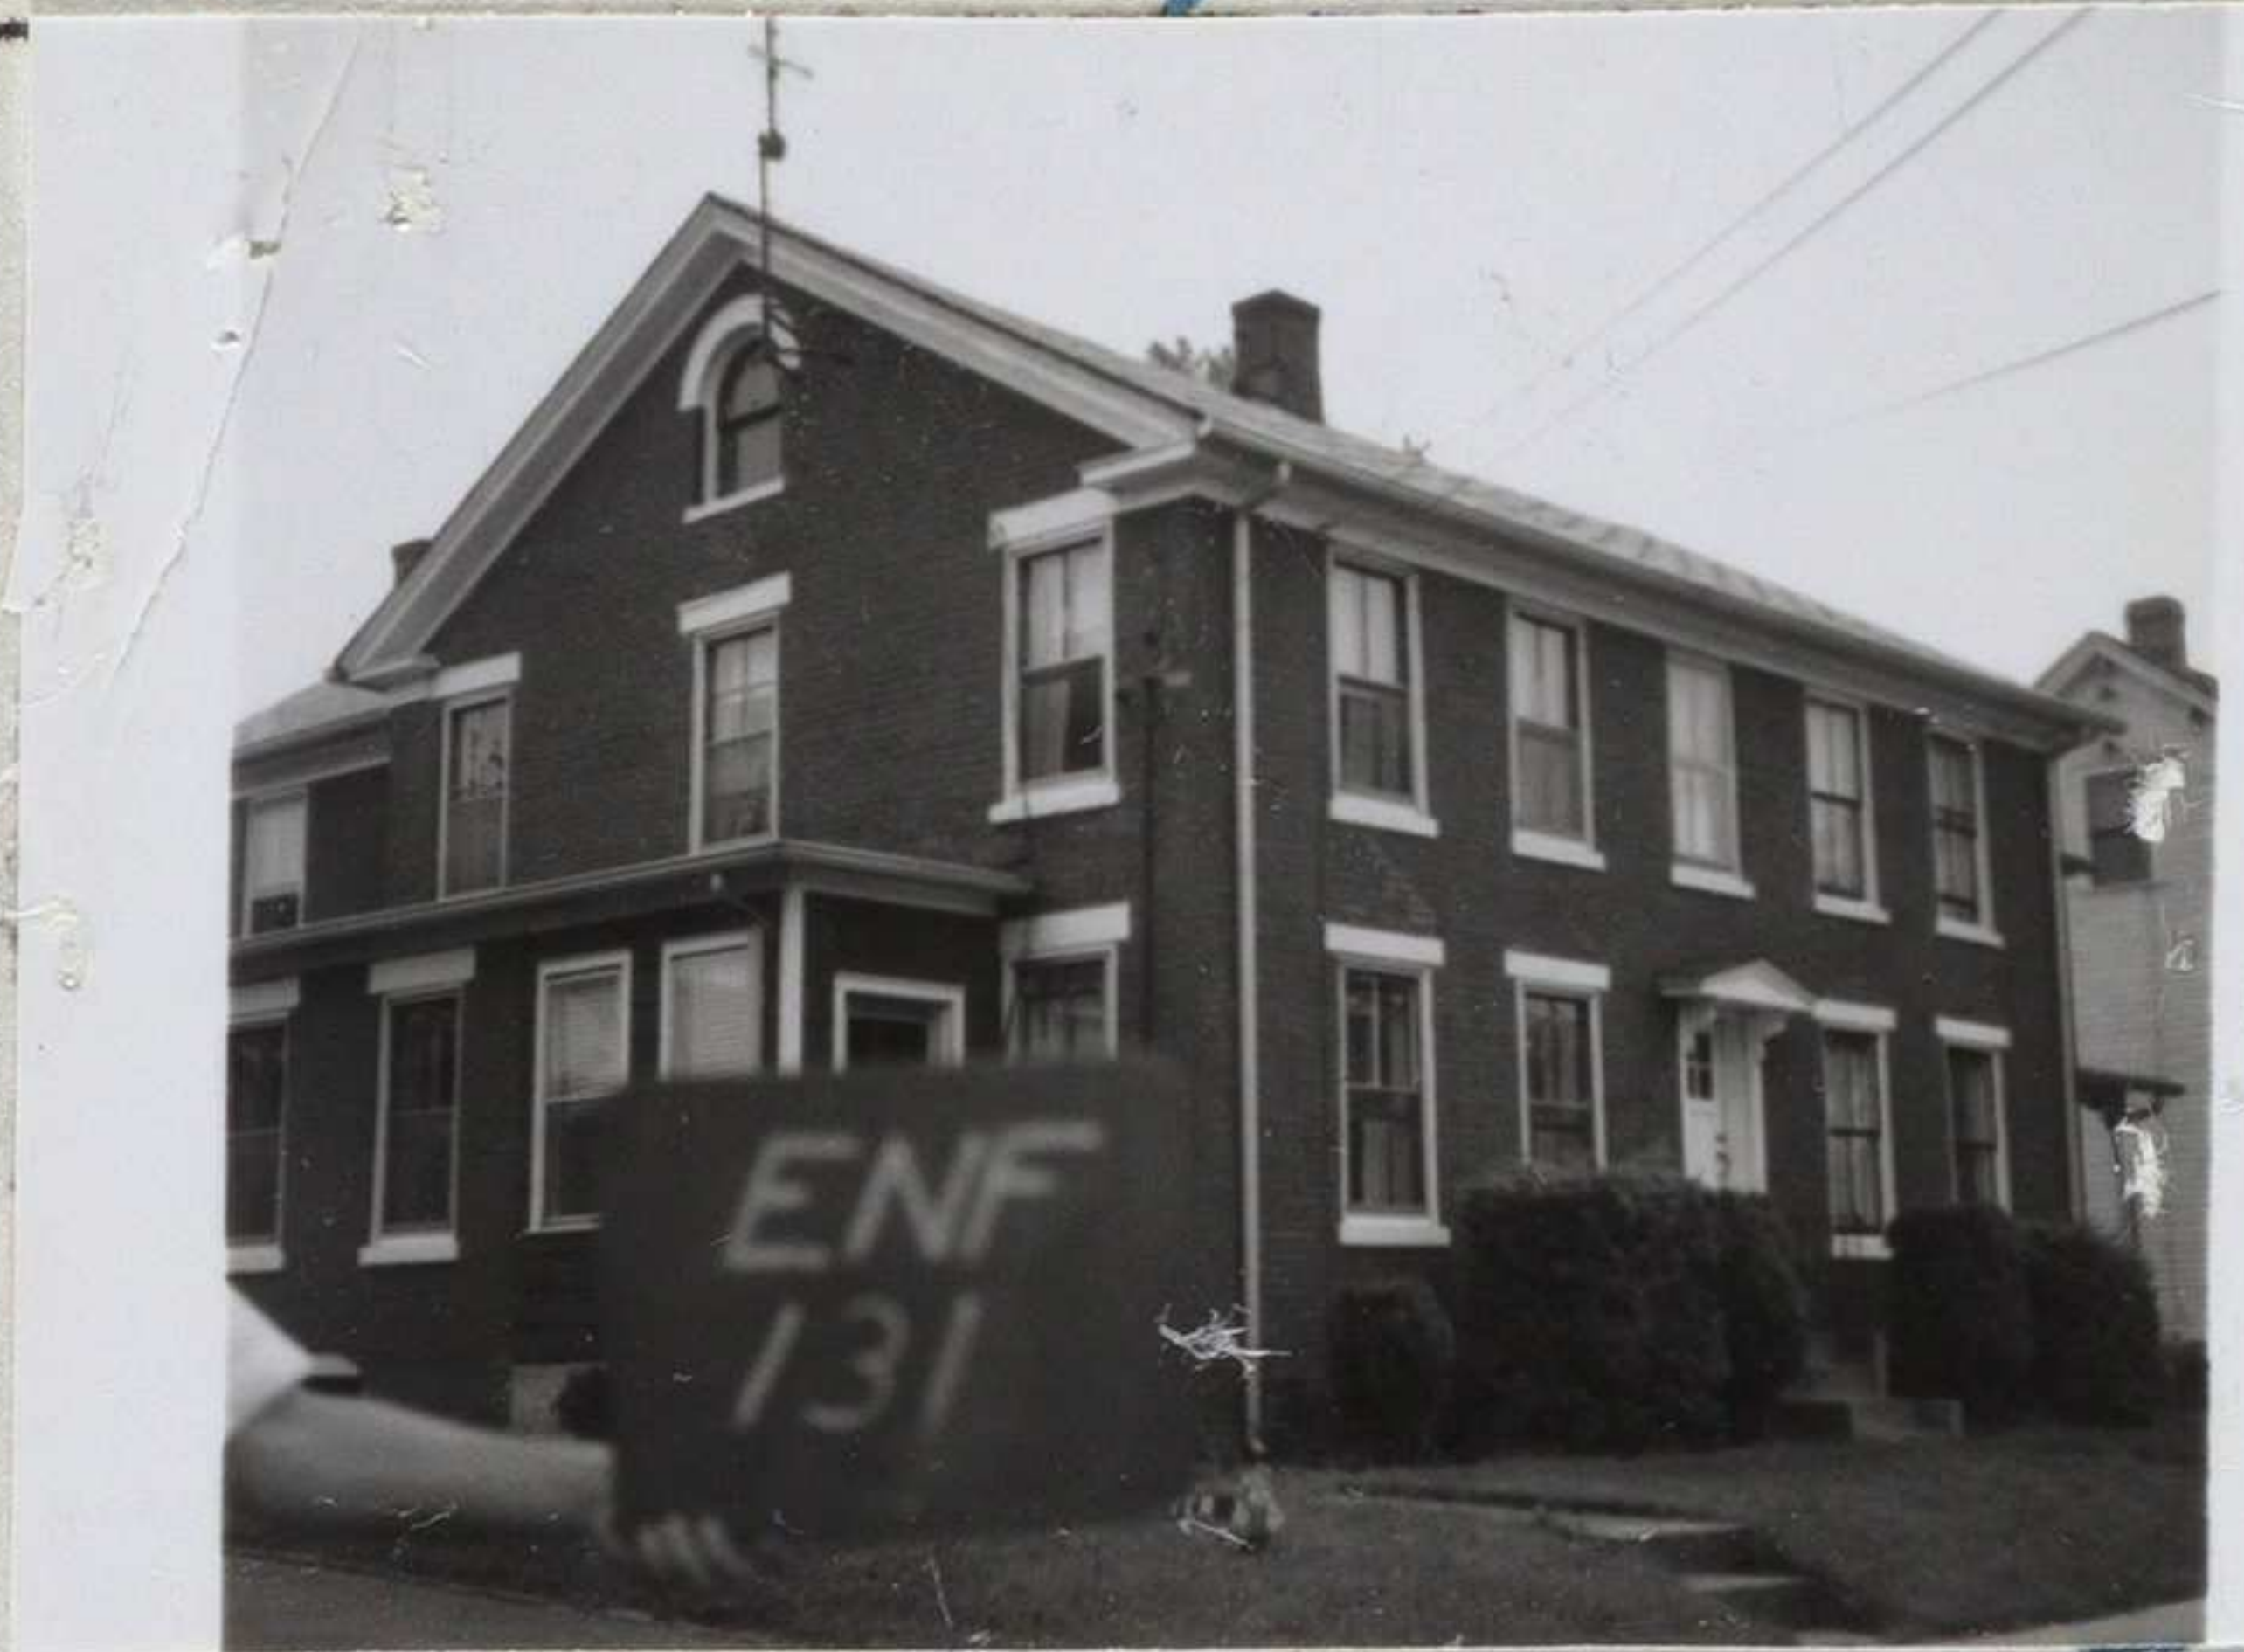
<p>7. PHOTOGRAPH <i>Enf 131</i></p>

<p>1. STATE <i>Ct</i> COUNTY TOWN <i>Enfield</i> VICINITY STREET NO. <i>45 Prospect St.</i></p> <p>ORIGINAL OWNER ? ORIGINAL USE <i>Residence</i> PRESENT OWNER <i>Shover</i> PRESENT USE ? WALL CONSTRUCTION <i>brick</i> NO. OF STORIES <i>2</i></p>		<p>HISTORIC AMERICAN BUILDINGS SURVEY INVENTORY</p> <p>2. NAME</p> <p>DATE OR PERIOD <i>1860</i> STYLE <i>late Greek Revival</i> ARCHITECT BUILDER</p> <p>3. FOR LIBRARY OF CONGRESS USE</p>		
<p>4. NOTABLE FEATURES, HISTORICAL SIGNIFICANCE AND DESCRIPTION</p> <p><i>The whole of this house is of brick. It is in five bays with windows with painted brown-stone sills and lintels. The pitch of the roof is shallow. New doors and windows fill the original openings.</i></p> <p>OPEN TO PUBLIC <i>No</i></p>				
<p>5. PHYSICAL CONDITION OF STRUCTURE</p> <p>Endangered ? Interior <i>poor?</i> Exterior <i>fair</i></p>		<p>6. LOCATION MAP (Plan Optional)</p>
